COMMUNITY
connectivity program

Washington Boulevard – Road Safety Audit

September 8, 2016

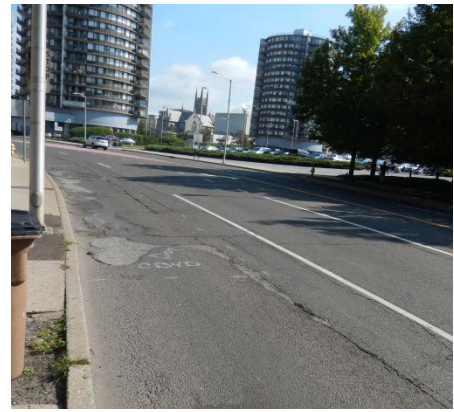
Figure 5. Pavement on Washington Boulevard Beginning to Deteriorate

- The pavement is in fair condition but beginning to deteriorate, there is some cracking and pot holes (Figure 5).
- There are several bus stops along the corridor but very few have shelters.

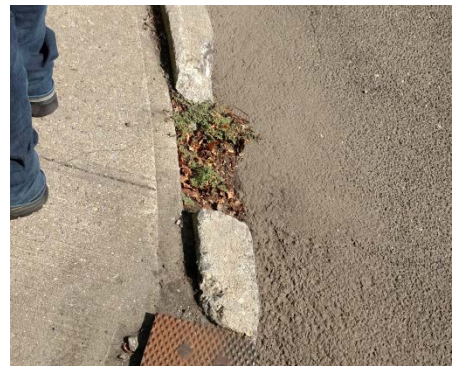
Figure 6. Broken Curbing

- There are heavy volumes of traffic, even during non-peak hours.
- The concrete curbing is broken or missing in several locations (Figure 6).
- There are bicycle friendly catch basin grates.

7. Paint and sign "do not block the box" at the Division Street Intersection.
8. Repair broken or missing concrete curbing.
9. Explore the potential removal of the Division Street signal.

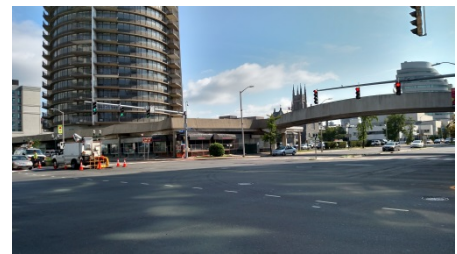
Figure 9. Washington Boulevard and Tresser Boulevard Intersection

Tresser Boulevard & Washington Boulevard (Figure 9)

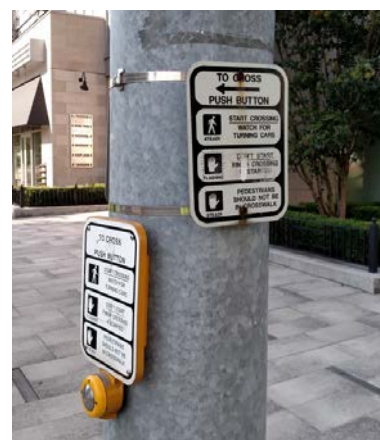
- The pedestrian signals have countdown heads but there is no audible indication.
- The pedestrian push button signs on the southwest corner of the intersection are confusing. There is a sign to push the button to cross Washington Boulevard but no button because the pedestrian signal is automatic with the Tresser Boulevard phase (Figure 10).

Figure 10. Confusing Pedestrian Push Button Placards

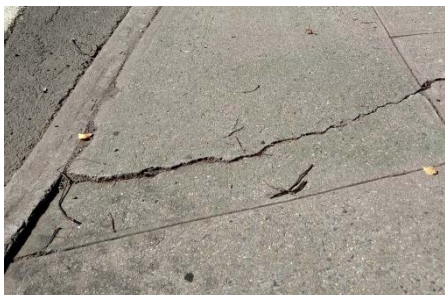
Figure 14. Cracked Sidewalk Ramp Without Tactile Warning Strips

- The ramps in the northwest and southwest corners are cracked and broken (Figure 14).
- There are crosswalks across all legs of this intersection but the ramps are not ADA compliant, and lack tactile warning strips. The crosswalk across the north leg of Washington Boulevard is diagonal and long. (Figure 15).

5. Close the unused curb cut for Citibank at 750 Washington Boulevard (Figure 38).
6. Repair the broken ramps in the northwest and southwest corners of the Division Street intersection.

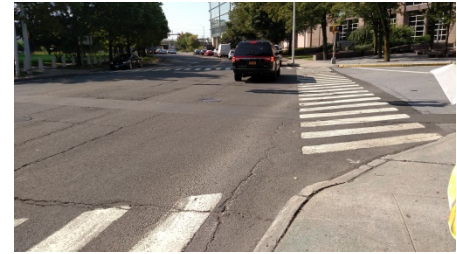
Figure 16. Traffic Backing-up Into the Intersection

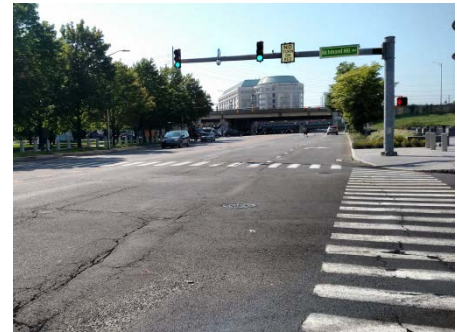
Figure 17. No Turn on Red Flashing Sign

- This intersection has an exclusive pedestrian phase. As a result, the traffic backs up along Washington Boulevard.
- There are three legs to this intersection, with all approaches prohibiting right turn on red (Figure 17).
- There are crosswalks across all legs of this intersection and each ramp has tactile warning strips. These ADA ramps are not aligned properly to direct pedestrians into the crosswalks. (Figure 18).

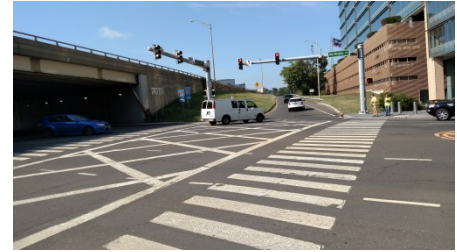
Figure 19. Don't Block The Box Pavement Markings

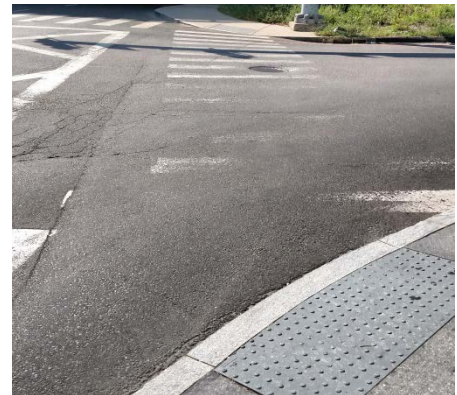
Figure 20. Faded Crosswalk

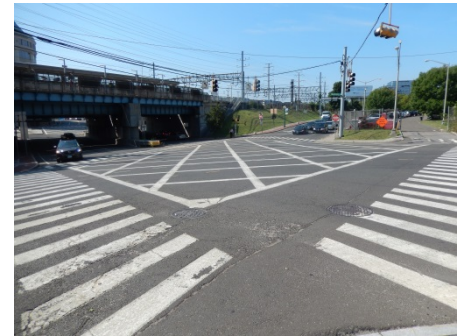
Figure 23. Washington Boulevard and South State Street Intersection

Washington Boulevard and South State Street (one way, eastbound) (Figure 23)

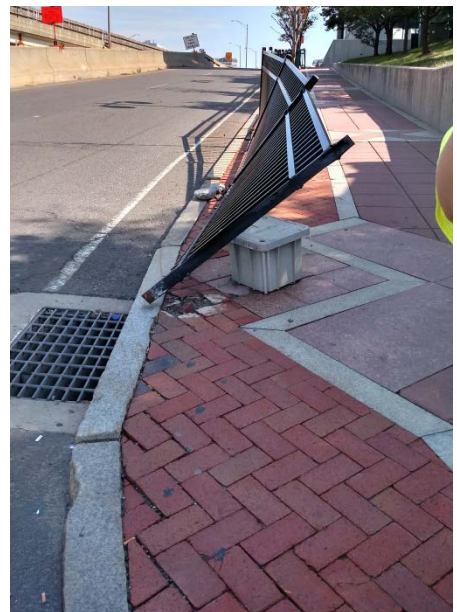
Figure 25. Broken Metal Fence

- The metal fence in the southeast corner by the station is broken (Figure 25).
- The landing ramp in the southeast corner is small, with insufficient depth. It does not meet current ADA standards.

19. Fix bent One Way sign at North State Street (Figure 43).
20. Repair the broken railing at the southeast corner of South State Street and Washington Boulevard (Figure 40).

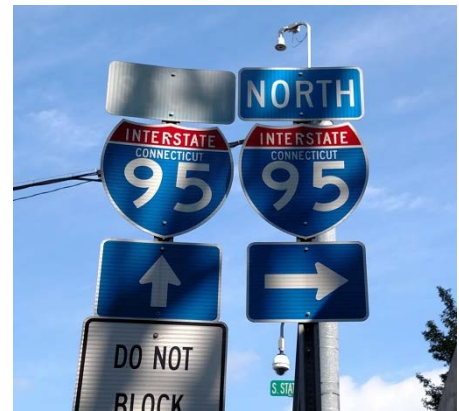
- The sidewalk is seven feet wide.
- The platform entrance for the Stamford rail station is located at the southwest corner of the bridge.
- It is very dark under the bridge. Several of the lights are out under the bridge (Figure 26).
- The south bound sign for I-95 is faded and unreadable (Figure 27).
- The street lighting pole is in the middle of the sidewalk.
- This is the only location in the RSA area which has shoulder lines.
- The route signs in the northeast corner are in the middle of the sidewalk and do not meet minimum height requirements.

Figure 27. Faded Signage

16. Replace faded signs with new retroreflective ones.
17. Raise sign heights to seven feet when in the sidewalk (Figure 42).
18. Signage to mark the entrance and exit.

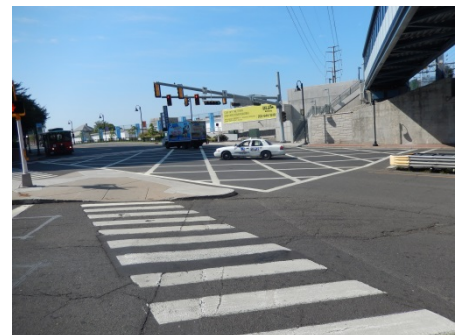
- There is a signalized channelizing island for rights from Station place onto Washington Boulevard northbound. The island has a pedestrian push buttons to call up the crossing phase. There are no tactile warning strips on the island and there is also no tactile warning strip on the NE curb ramp, north of the island (Figure 28).
- There are crosswalks across Station place and the southern side of Washington Boulevard. The northeast curb ramp is the only ramp with tactile warning strips.
- The sidewalk is approximately 7 feet wide.
- The sidewalk across Washington Boulevard is painted with red and white stripes.

Figure 28. Channelizing Island Lacking Tactile Warning Strips

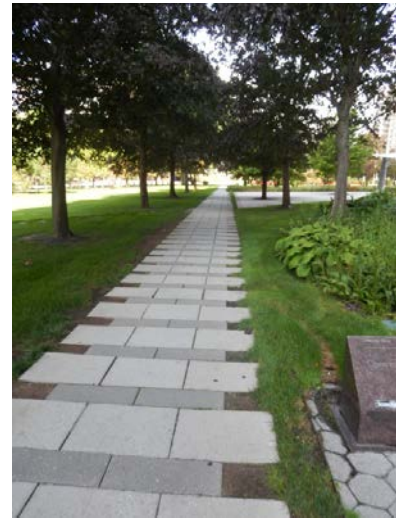
- CTDOT is raising the mid-block crosswalk (creating a speed hump) on North State Street to create awareness since this is a heavily used crossing.
- The lawn in front of the UBS building (on the east side of Washington Boulevard) acts as an urban park (Figure 29).

Figure 29. UBS Building Lawn

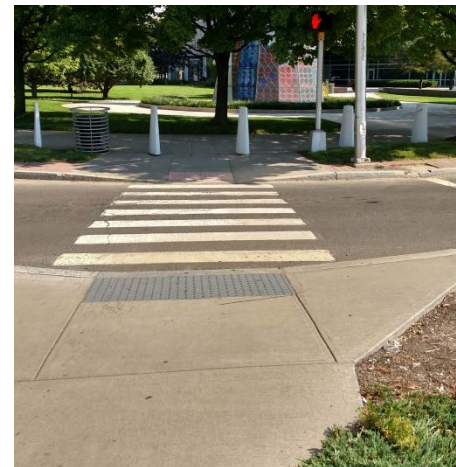
- The pavement on Washington Boulevard is in fair condition but deteriorating quickly. It is unknown where it is on the VIP list.
- At North State Street the channelizing island is signalized and has both red and green arrows and right on red is allowed. Vehicles often do not yield to pedestrians crossing when the signal is red. (Figure 33).

Figure 33. Pedestrian Crossing, Vehicles Don't Yield To

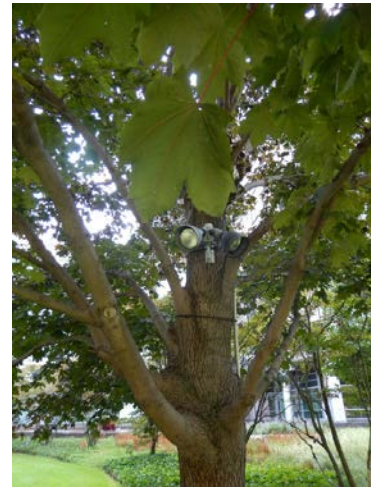
- There are lights in the trees at the UBS park and along the sidewalk edges but in general the park is not well lit (Figure 34).
- There are several bus stops along Washington Boulevard but many do not have shelters. The shelters are managed through the Stamford Transit District and to install new ones you must go through them. (Figure 35).
- Sidewalk improvements are needed between Richmond Hill Avenue and 200 feet south of Tresser Boulevard.
- Right turn signal and poor sight line at Station Place and Washington, add auxiliary pedestrian signal.
- In some locations tree branches are beginning to block to pedestrian signal heads, in particular the northeast corner of North State Street.

Figure 34. Lights in Trees

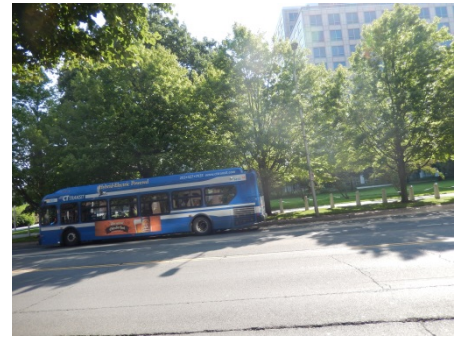
Figure 35. Bus Waiting at Stop

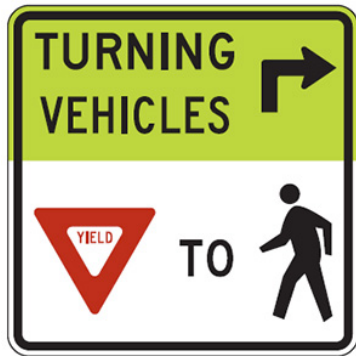
Figure 39. Example of "Yield to pedestrians on red sign"

15. Install a "Yield to pedestrians on red sign" at the right turn for the channelizing island at North State Street or convert to no right on red (Figure 39).

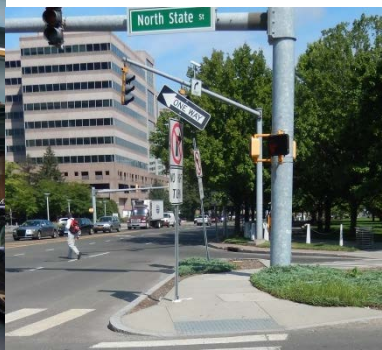
Figure 43. Fix Bent Sign

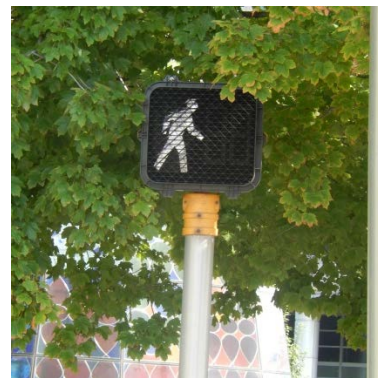
Figure 44. Trim Vegetation From Signal

13. Fix sunken in gate valve in crosswalk at Richmond Hill Avenue (Figure 41).
14. Trim vegetation around pedestrian signals where beginning to encroach (Figure 44).

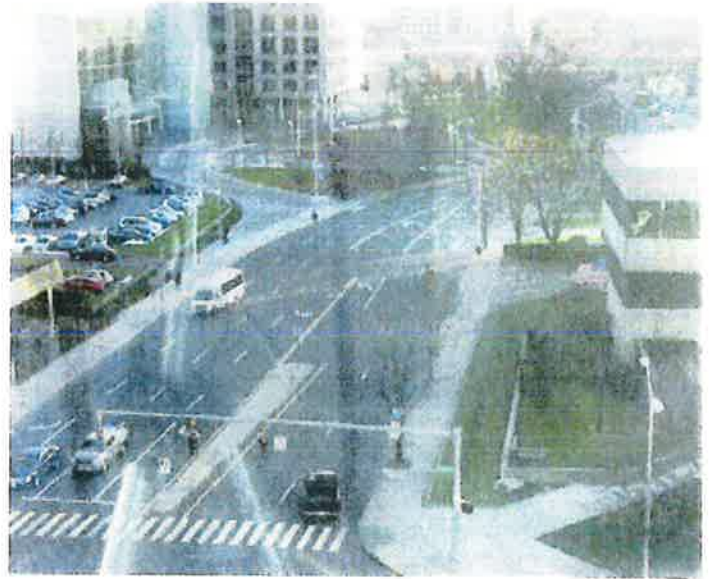
Washington Boulevard, however, is not designed to fit into its urban context and is likely a deterrent to the presence of children, seniors and cyclists. South of Tresser Boulevard, Washington loses the urban design elements that it has to the north, including on-street parking, a planted median, and aesthetic lampposts. Their absence communicates to motorists that they are no longer in “downtown” and should speed up as they approach the area around the Interstate. The gentle curve in Washington Boulevard is an existing feature that can help to slow traffic, but the dimensions of the roadway do not reinforce this desired behavior.

Washington Boulevard - Looking South from the Stamford Government Center

- Redesign Washington Boulevard with landscaped medians that provide space for safe pedestrian refuge;

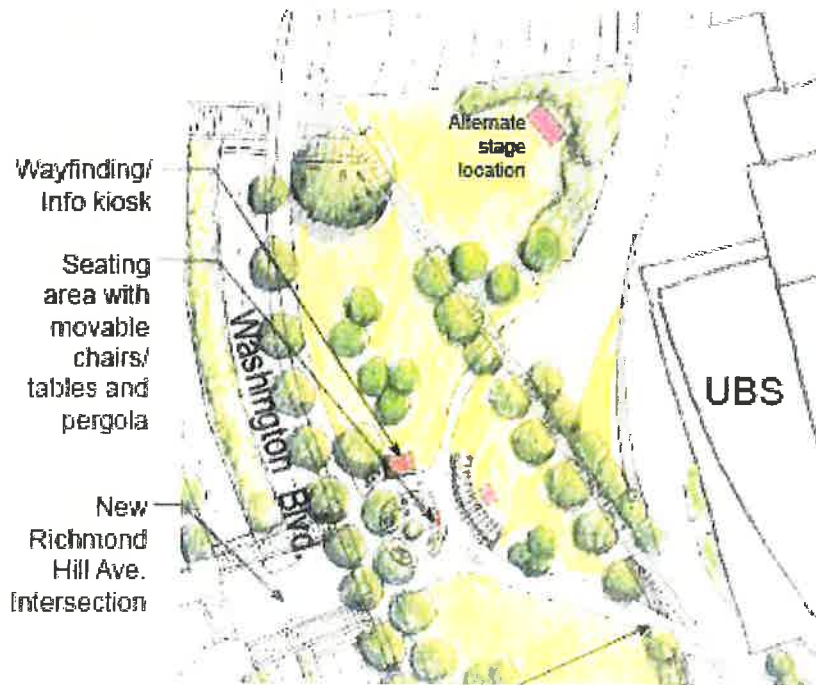
Site 1A Recommended Pedestrian Improvements

- Add ground-floor retail to new buildings being developed along this stretch of Washington, including a future building on the site of the UBS parking lot (immediately north of the existing UBS building) and the potential redevelopment of the old Stamford Advocate building (southwest corner of Washington and Tresser).

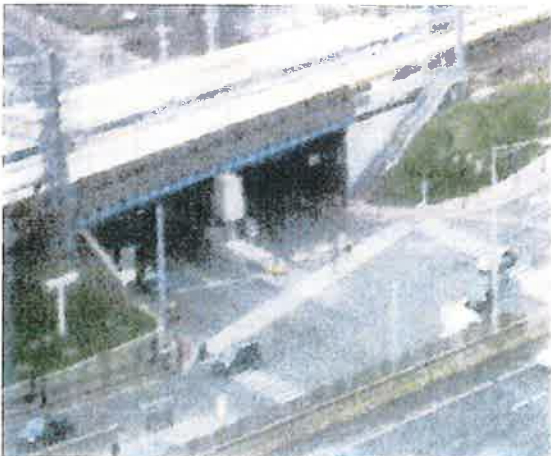
Intersection of Washington Blvd. & S. State St.

The intersection of Washington Blvd. and S. State St. was not designed to accommodate pedestrian traffic. Despite a steady flow of pedestrians coming from offices, the hotel, parking and housing to the south and west, the intersection is very large, and many pedestrians do not make it all the way across Washington on one cycle length, forcing them to wait in the middle of the roadway. There is barely any sidewalk width on the southwest corner of the intersection, which forces passing pedestrians to walk in the street, and new residential development to the south will increase pedestrian volumes. Further complicating this situation are the shuttle buses that back up traffic while waiting to enter their drop-off and pick-up area--a situation that could easily be remedied.

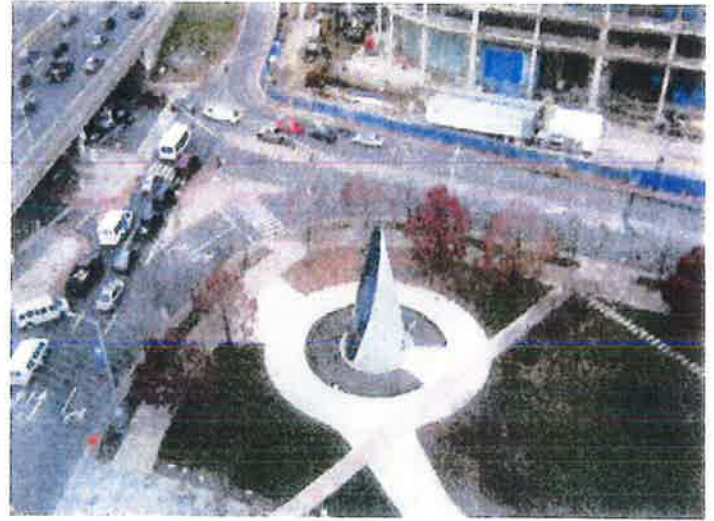
Although most pedestrians from the train station currently use the mid-block crossing of N. State St. (see evaluation of Site 1C for volume comparison), there will be a significant increase in pedestrian traffic at the intersection of Washington Boulevard and N. State Street with the completion of the new RBS office building and new development to the south of I-95. This intersection does not currently provide for pedestrian crossings of all street approaches. There also does not seem to be sufficient vehicular turning movements to justify a channelized double right-turn lane from westbound N. State St. to northbound Washington Blvd., and the radius of this right turn is too large for a pedestrian area.

Intersection of Washington Blvd. & N. State St. - Looking East from UBS Building

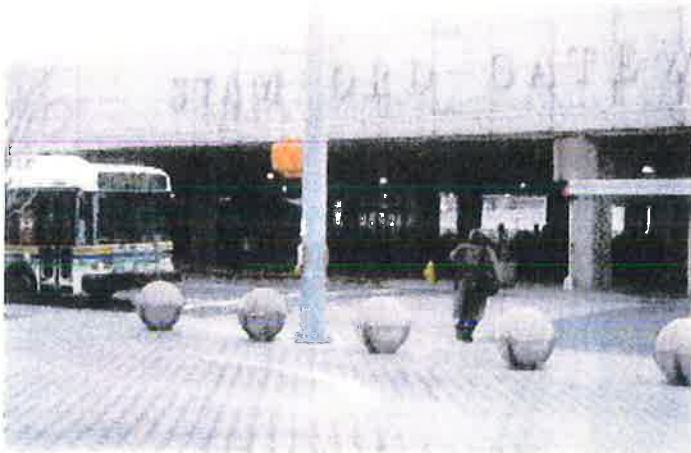
Mid-Block Crossing of N. State Street - Looking South from UBS Plaza

The mid-block crossing of N. State Street is well marked and very heavily used. It is a successful recent effort to make walking safer in this area. As shown in the graph below, 1202 pedestrians used this crossing during one 90 minute observation. Each data point represents the number of pedestrians crossing together, prompted by either a pedestrian signal phase or a significant break in traffic. This compares to roughly 60 people crossing N. State Street immediately to the west at Washington Boulevard during the same time period. There were several bicycles observed using the mid-block crossing, and many pedestrians had to run across the intersection to get out of the way of approaching automobile traffic. It was also common during the morning peak period for

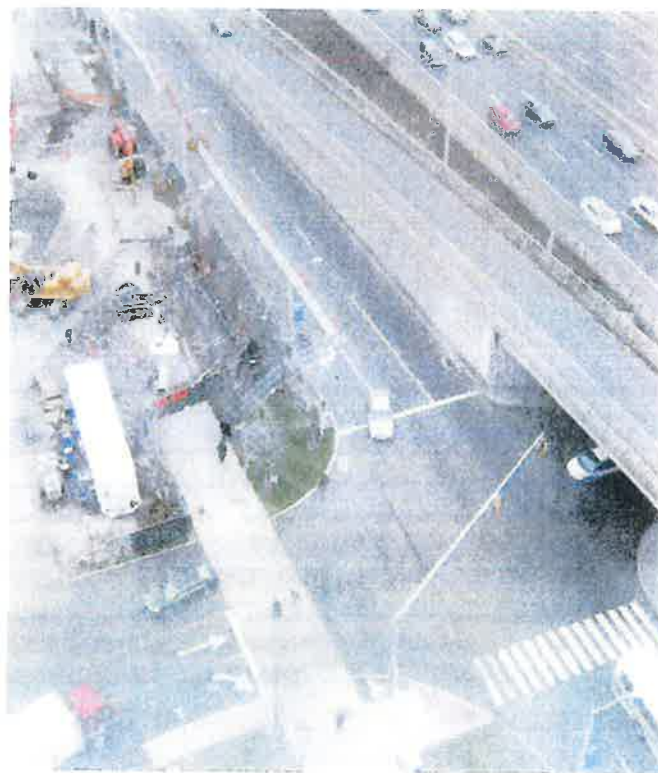
Construction on N. State Street at UBS Garage Access Road

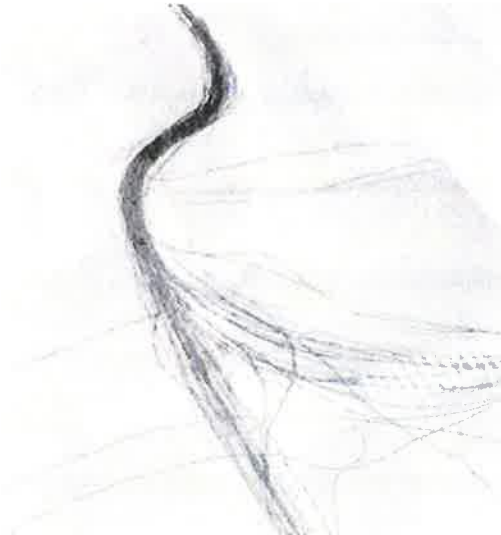
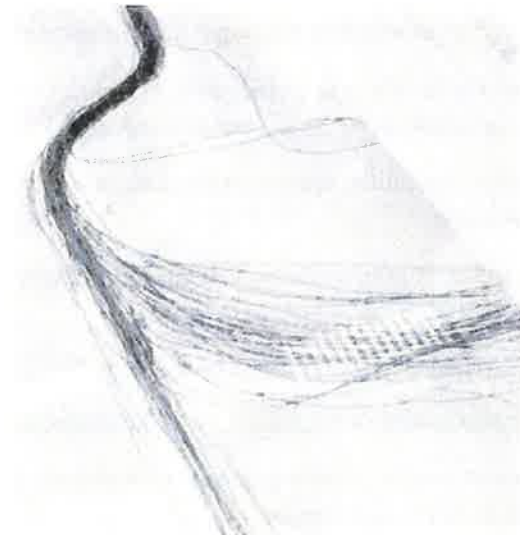
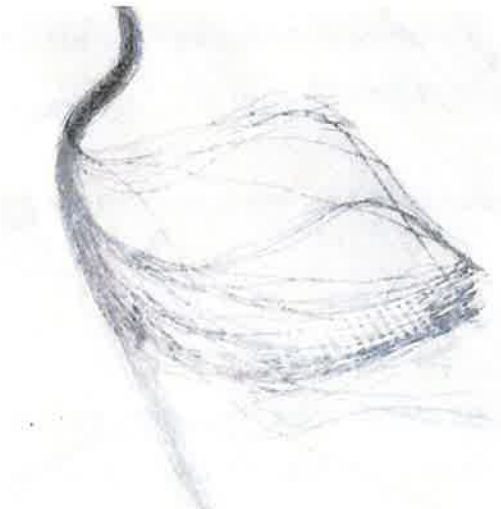
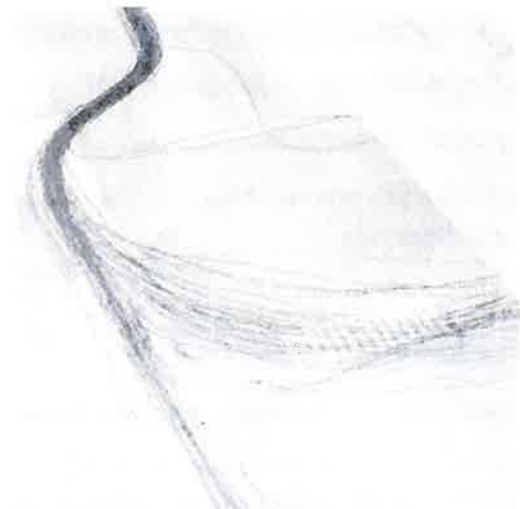
**PEDESTRIAN TRACKING BETWEEN 7:15 AM AND 8:15 AM
INTERSECTION OF NORTH STATE STREET & UBS GARAGE ACCESS ROAD**

PPS observed that most pedestrians crossing N. State Street near the UBS garage entrance do not use the existing crosswalk but rather cut across the intersection diagonally because of a lack of traffic on the side street that intersects N. State. Each line in the graphics above represents the path of one pedestrian from 7:15 am to 8:15 am.

- Permanently narrow N. State St. to two lanes (this may provide space for a Class I separated bicycle lane);
- Study ways to reduce traffic on N. State St., such as limiting the street to buses, bicycles and high-occupancy vehicles or relocating highway entrances/exits;
- Remove the northbound I-95 exit ramp, and relocate it further to the east;
- Implement audible and pedestrian countdown signals at all crosswalks around the train station;
- Display real-time travel information at the bus bays;
- Display real-time transit information on the "Stamford Gateway" so travelers know when their trains or buses will actually arrive and whether they have time to grab a newspaper or pick up dinner; a news "zipper" visible from the UBS plaza would also be appropriate in this location to draw people towards the train station and enhance the pedestrian experience;

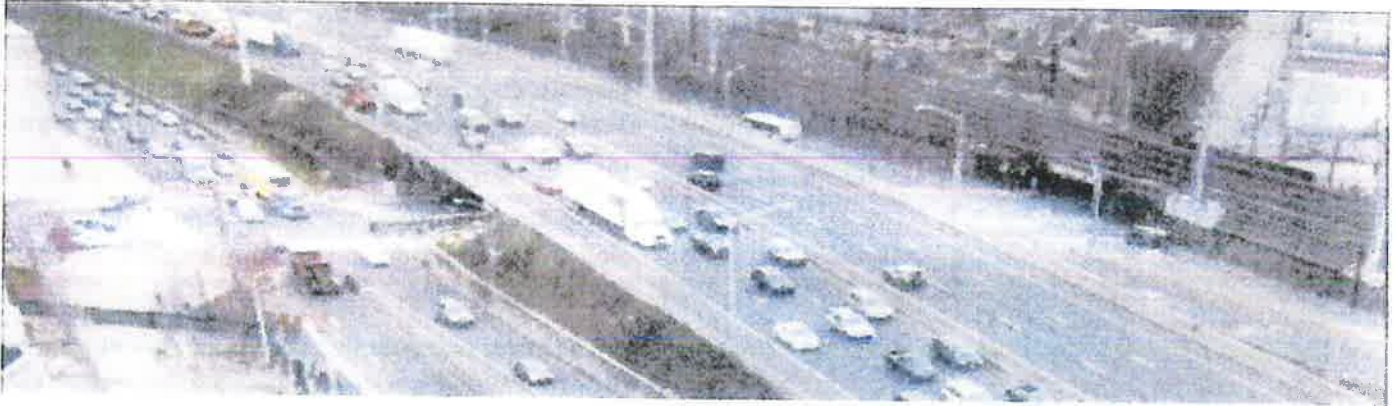
Atlantic Street Running beneath I-95 and the Railroad Trestle - Looking East from UBS Building

Site 1D encompasses the intersections of Atlantic Street with Federal, N. State and S. State Streets. The area around Atlantic Street and the train station, especially south of I-95, is experiencing a major redevelopment with new office space and housing units. Therefore, consistent with Stamford's Master Plan, Atlantic Street can become both the major pedestrian spine of downtown Stamford and street that unites the areas north and south of I-95. It is imperative that this street be designed to prioritize pedestrians and ensure their safety and comfort. The planned state project to widen and improve Atlantic Street under the railroad overpass is an important element of this strategy, as are the recommendation ideas presented below.

- Add sidewalk seating and more landscaping throughout the site;
- Install signage to direct pedestrians towards downtown and the train station;
- Install maps and lighting and paint the walls and ceiling underneath I-95 and the railroad trestle to improve visibility and aesthetics along Atlantic Street. In New York City, the DOT and a local BID put together a “This VVay” lighting installation project that transformed the formerly dark and forbidding Brooklyn Bridge stairwell and underpass into a welcoming pedestrian space (photos at right).

- Complete the design and construction of the Atlantic Street railroad overpass project to widen the sidewalks on Atlantic Street and enhance visibility into the underpass;
- Widen the sidewalk to accommodate bicycles or add bike lanes to Atlantic, N. State and S. State Streets;
- Add a water feature or sculpture to the large sidewalk space on the corner of Atlantic and N. State to create a place (as in the photo below);

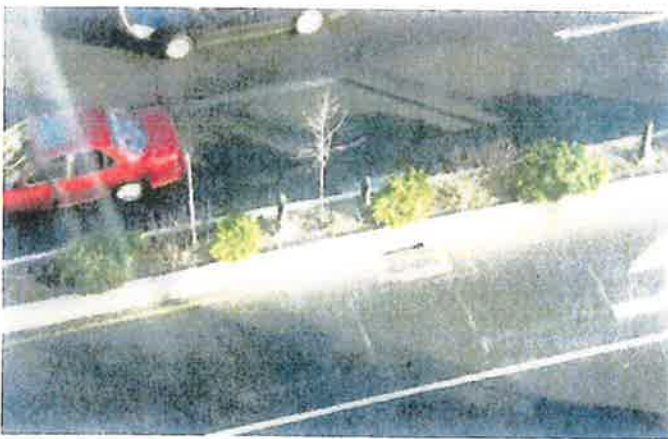
As mentioned previously, this intersection is the border between what is generally recognized as the true downtown of Stamford and the area around the train station and I-95. North of Tresser, Washington Blvd. has on-street parking, narrow lanes, a planted median and aesthetic lamp posts. South of Tresser Blvd., all of the above treatments disappear, communicating that the area south of Tresser Blvd. is no longer “downtown.” The superblock pattern, large building setbacks and lack of street level uses south of Tresser Blvd. further communicate that the area between Tresser Blvd. and the train station is not designed for urban pedestrian activity.

Planted Median on Washington Boulevard

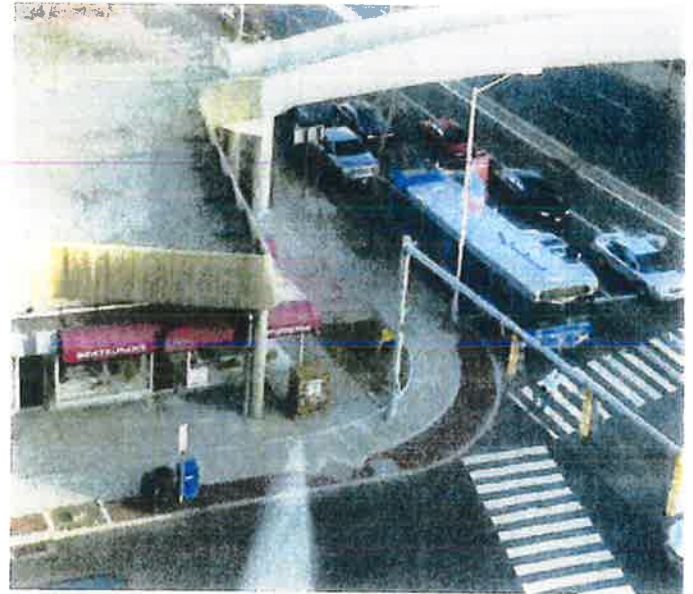
Northeast Corner of Intersection of Washington and Tresser Boulevards - Looking East from Stamford Government Center

Additionally, this stretch of Tresser Blvd. is three lanes in each direction, but it is narrowed to both the east and west of this intersection. There did not seem to be enough traffic on Tresser Blvd. during PPS's observations to justify six through lanes in what is desired to be an urban, walkable area.

- Maintain sightlines from the south to the northeast corner of Washington and Tresser Boulevards, as it is an important corner for visually drawing pedestrians into downtown;

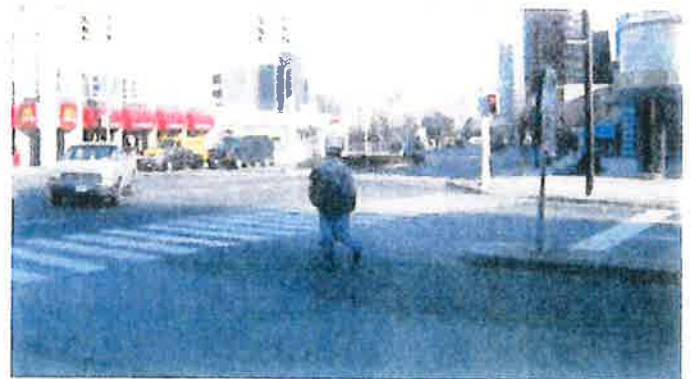
Pedestrian Running across Atlantic Street

Like the intersection of N. State Street and the UBS garage access road, and as shown in the pedestrian tracking below, people tend to cross where the distances are shortest rather than at sanctioned crosswalks. This is an issue on the western leg of Broad Street because the crosswalk does not align with the corner of the intersection. Pedestrians are cutting across the intersection from the southwest to the northwest corners because the crosswalk ends/starts west of the intersection rather than at the corner.

- Shrink and realign the intersection to shorten crossing distances;
- Widen and extend the medians on both legs of Broad St. and on Atlantic St. out through the crosswalk to provide better pedestrian protection for those waiting to cross in the middle of the street;
- Raise the entire intersection, an idea that came out of Urban Engineer's focus groups, to slow traffic entering the intersection and signal that this is the heart of downtown Stamford;
- Design Bedford Street as a "Festival Street" so it is easily closed for downtown events by removing the grade change between the sidewalk and street, creating the continuous feel of a plaza, and use movable barriers to facilitate quick street closings.

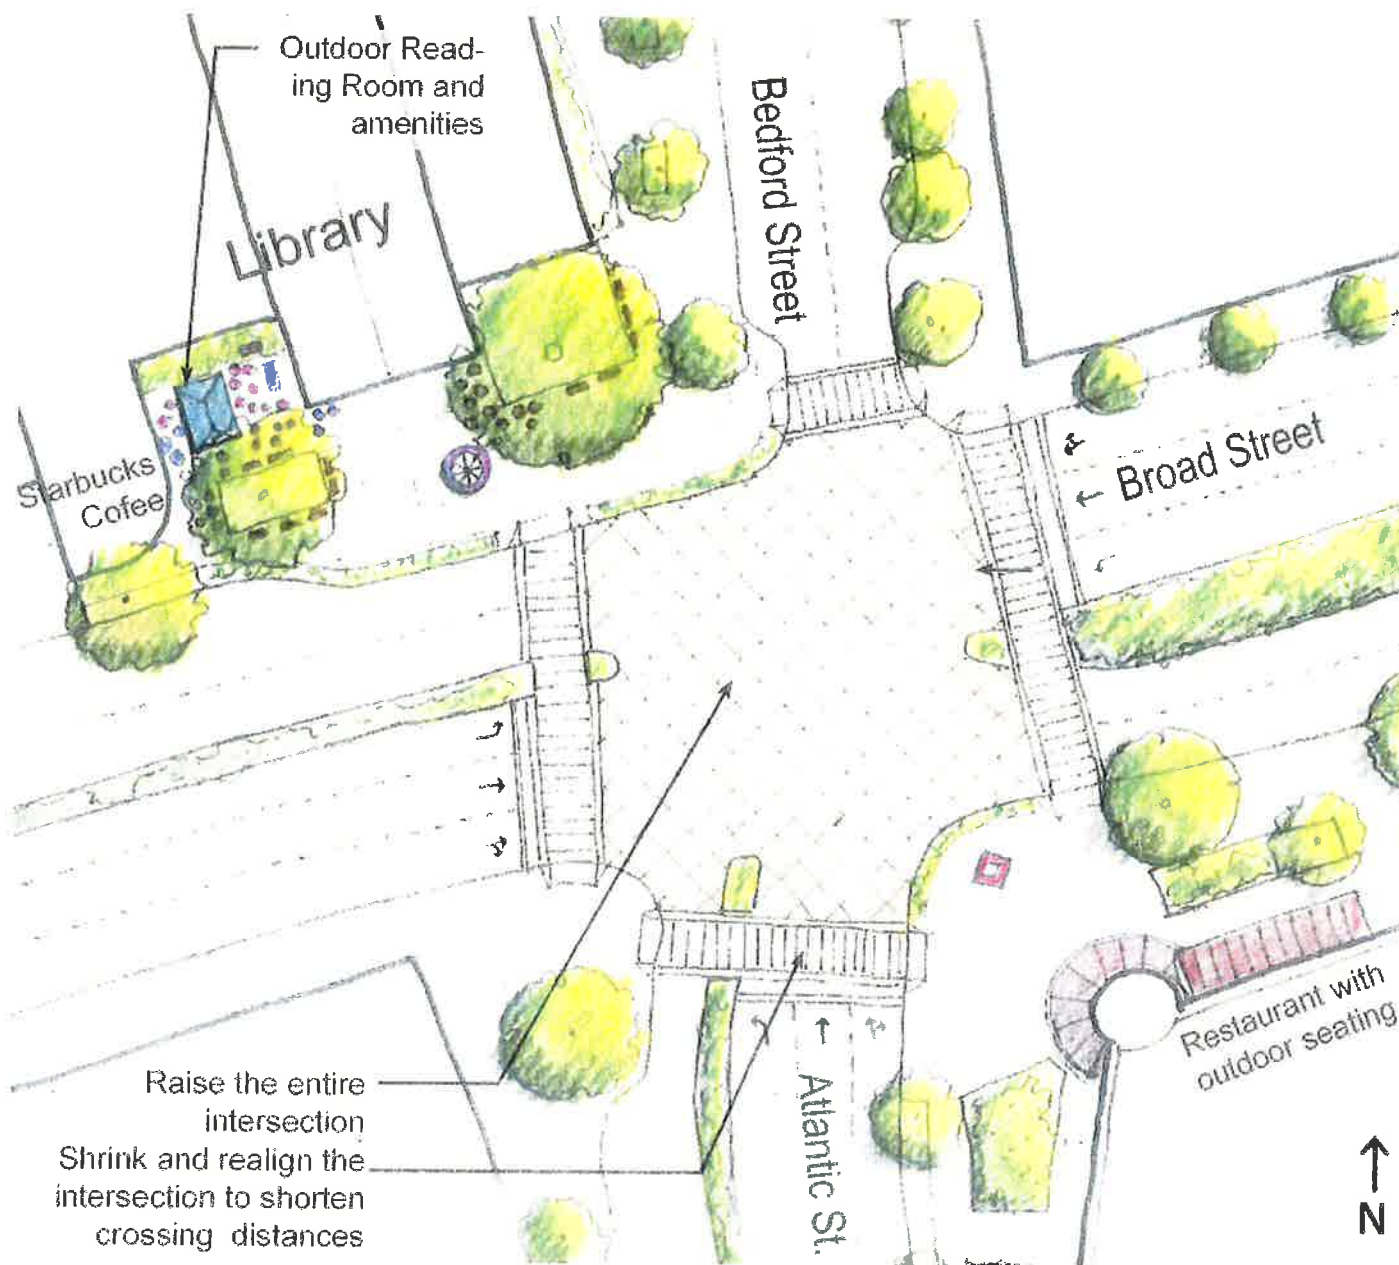
SITE3

Recommended Pedestrian Improvements for the Intersection of Broad, Atlantic and Bedford Streets
